NWEF REPORT 1079

EVALUATION OF A-7E AIRCRAFT THERMAL RADIATION CLOSURE FOR LIGHT LEAKAGE

NAVAL WEAPONS EVALUATION FACILITY
ALBUQUERQUE, NEW MEXICO 87117

20 April 1971

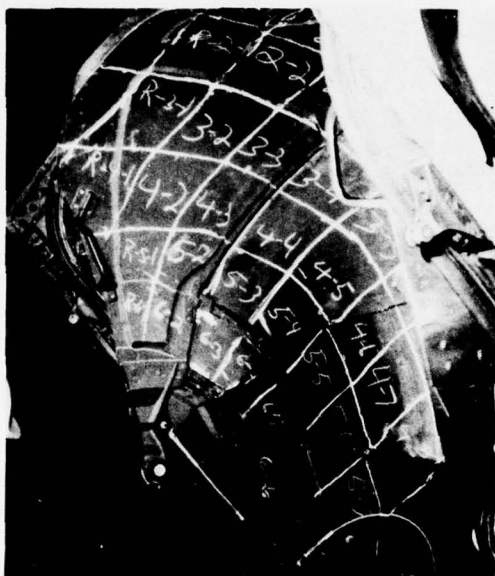
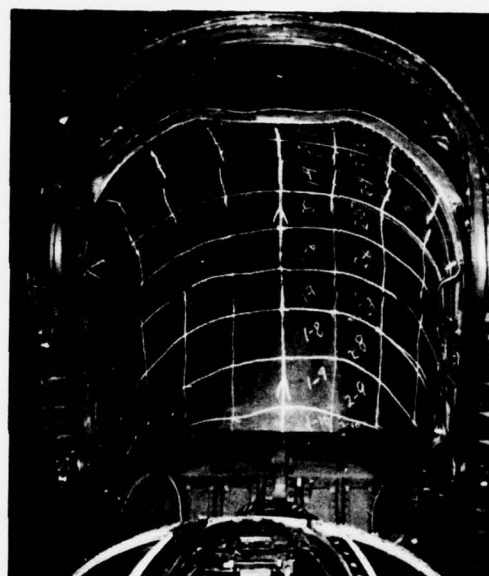
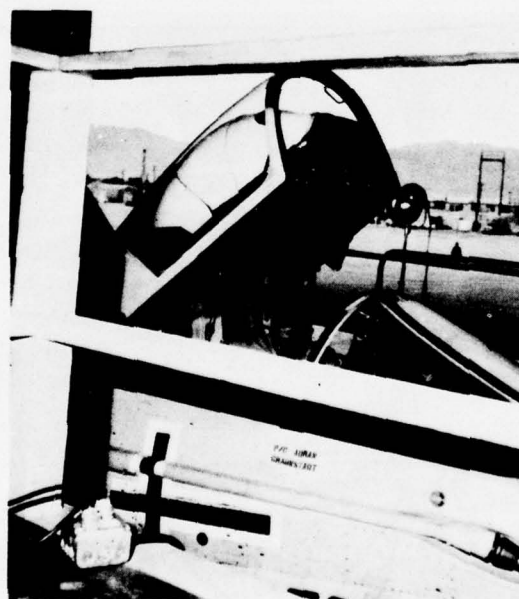
FIGURE 2. SEGMENT MARKINGS FOR POSITION IDENTIFICATION

1. Major transmission areas on both left and right sides at positions 5-6 and 6-6 (Fig. 2) along the interface between the fixed segment and the movable segment, with particular emphasis on the area around the metal-slider hinge.

4. Major transmission area at positions L-5-2 and L-6-2 (Fig. 2) along the interface between the forward and center movable segments.
5. Numerous scratches visible in the closure material. The forward movable segment appeared slightly more translucent than the center and aft movable segments.

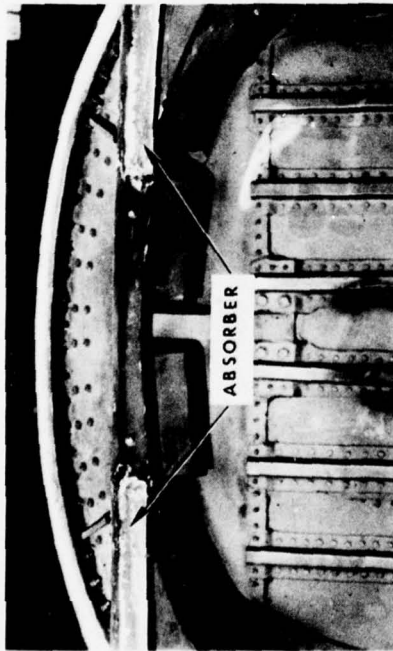
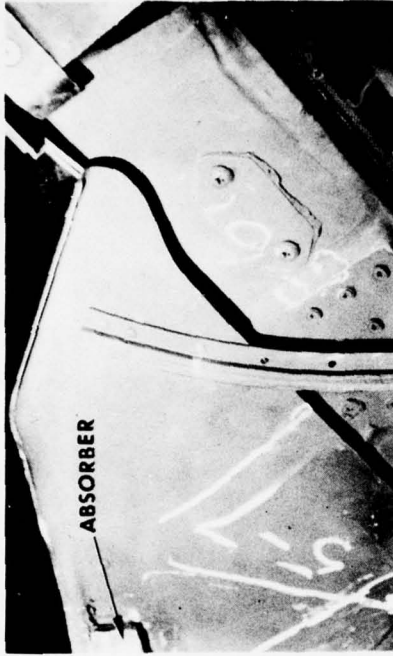
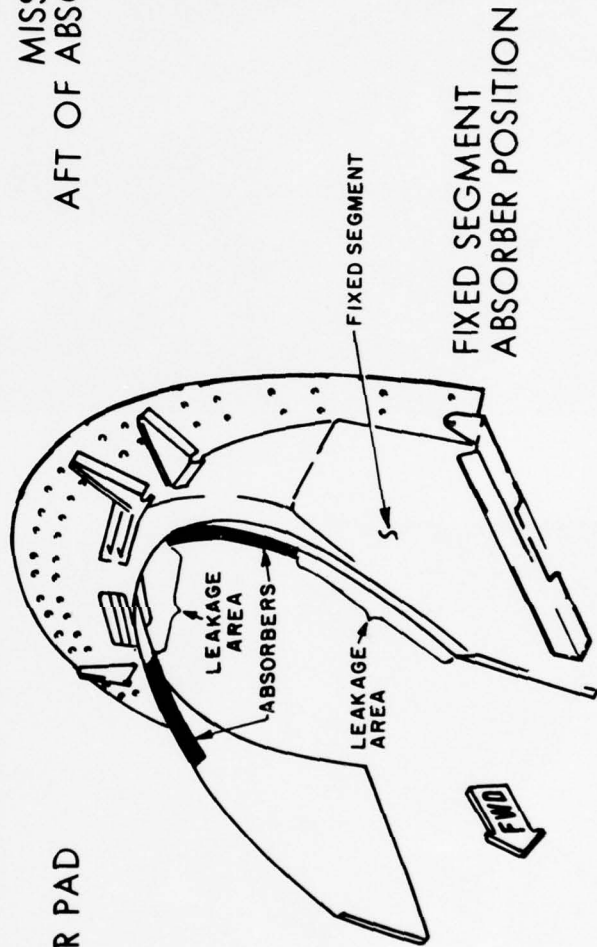
FIGURE 4. CAUSE OF LIGHT LEAKS ALONG AFT-MOVABLE SEGMENT AND FIXED SEGMENT

The gross leak area aft of the seat along the rear edge of the aft movable segment was traced to lack of a seal for a length of approximately 12 inches along the top periphery of the fixed segment (Fig. 4). LTV was contacted to determine if for some reason lack of a seal at this point was limited to aircraft BuNo 156739. It was established that the only seal along the interface between the aft movable segment and the fixed segment is provided by the absorber (LTV part No. 215-21136-9), and that this condition is common to all A-7E aircraft.

Lack of a seal along the forward edge of the fixed segment (Fig. 4) was also determined to be the cause of light transmission noted at positions 5-6 and 6-6 along the interface between the aft movable segment and the fixed segment in the area of the metal-slider hinge on both left- and right-hand sides.

MISSING SEAL
FWD OF ABSORBER PAD

MISSING SEAL
AFT OF ABSORBER PAD

5. Severe light leaks exist at the interface between the fixed segment (LTV part No. 215-21136-86) of the segment assembly (LTV part No. 215-21136-90) and the external face of the aft movable segment. Although the absorber (LTV part No. 215-21136-91) acts as an effective seal along part of this interface, the observed leaks are directly attributable to lack of a seal forward and aft of the absorber along the interface length.

Prior to Phase III testing, an attempt was made to eliminate leakage areas at the interface between the aft movable segment and the fixed segment (Fig. 4). Seal material available at NWEF was bonded to the fixed segment both forward and aft of the absorber (LTV part No. 215-21139-91) to complete the seal pattern around the fixed segment edge. Severe interference problems were encountered with the materials used. Particular problems involved the seal aft of the absorber along the periphery of the fixed segment. Because of clearance variations during closure operation, severe interference necessitated removal of the aft seal installation. These problems could be minimized if the seal were positioned on the outside edge of the aft movable segment rather than the fixed segment. There would then be no interference during closure, and a seal would result as the aft segment completed its motion. Installation of seals along this interface was intended to demonstrate that a complete seal along the fixed segment could eliminate all remaining leakage paths yielding out-of-specification values, and not as a proposed fix in lieu of an engineering evaluation by LTV.

1. Install a seal along the entire interface between the fixed segment of the segment assembly and the aft movable segment to ensure a reduction to specification levels of all light transmitted to the cockpit, either directly or indirectly.

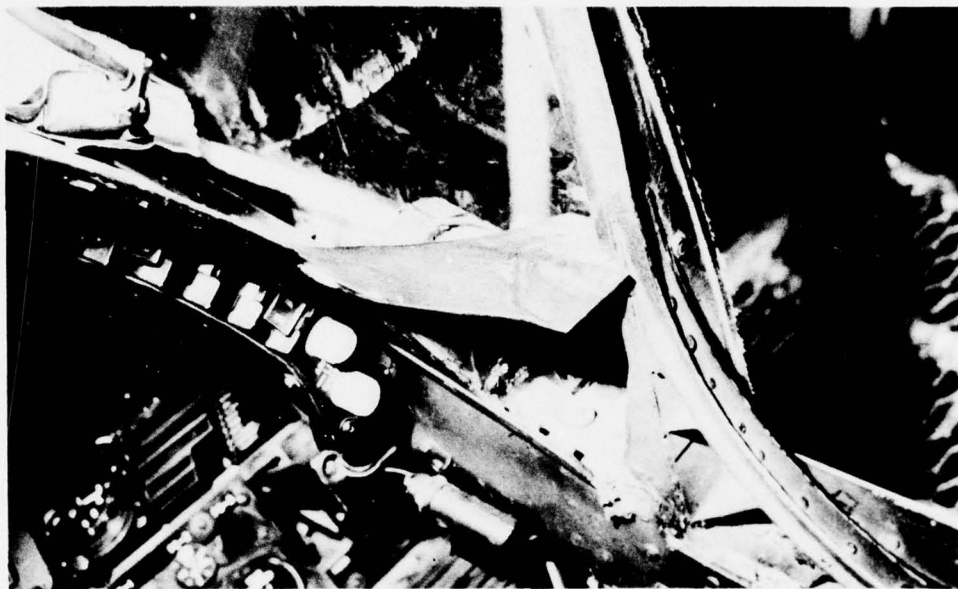
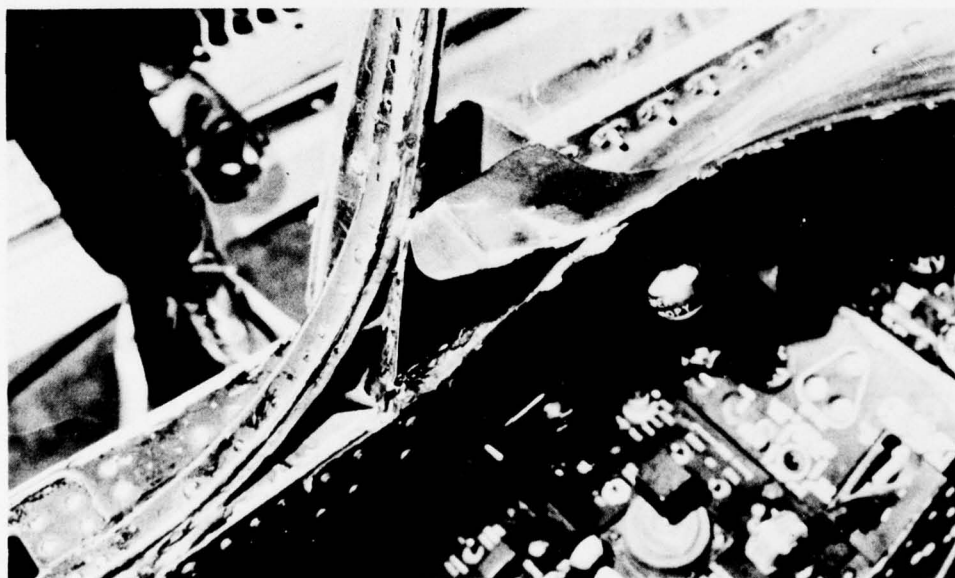
**FIGURE 5. COWLING SEAL LOCATIONS.
BEFORE SEAL INSTALLATION**

It was noted that seals (LTV part Nos. 218-21136-7 and -8) at left and right corners of the cowling had not been installed during incorporation of AFC 111 (Fig. 5). These seals were installed as part of the retrofit operation (Fig. 6). Figure 5, sheet 5 of 6, of AFC 111 shows the 218-21136-7 and -8 seals as rectangular, while the marked drawing (218-21136, sheet 3) furnished NWEF indicates that these seals should be cut to fit. Difficulties encountered during seal installation revealed that a hand-fit operation

is necessary to eliminate all leakage paths. AFC 111 does not specify the requirement for a hand fit operation.

3. Modify Fig. 5, sheet 5 of 6, of AFC 111 to show that cowling seals (218-21136-7 and -8) must be cut to fit as required to eliminate leaks.

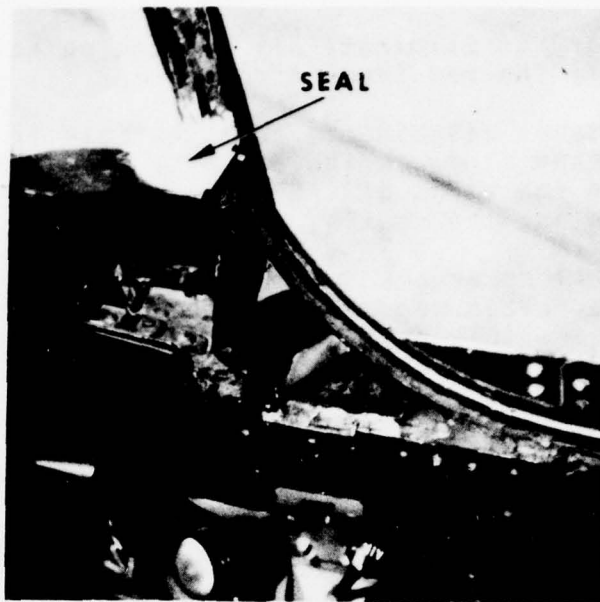
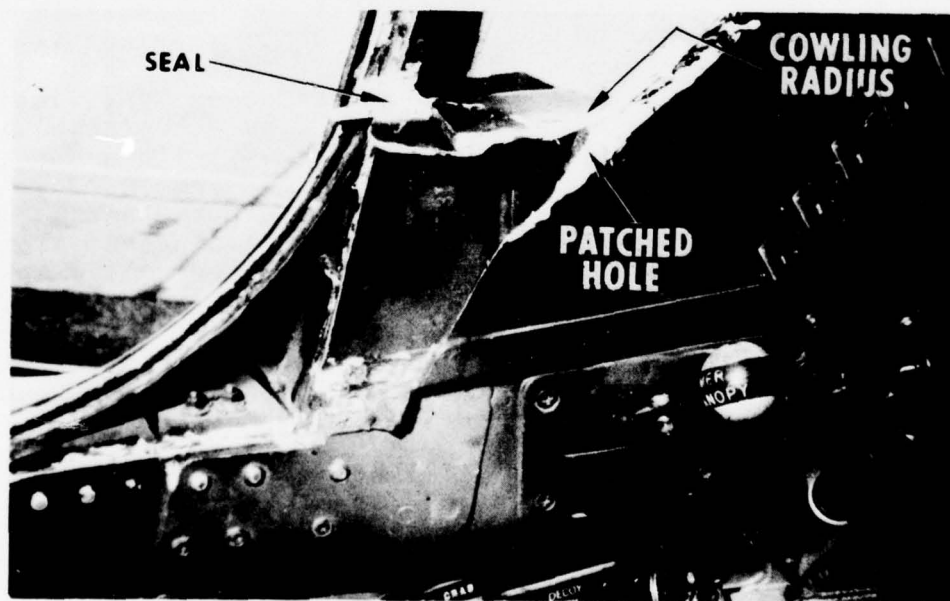
FIGURE 6. COWLING SEAL LOCATIONS- SEALS INSTALLED

An attempt was made to seal the hole in the cowling on the left-hand side, as indicated by the seal material visible to the right of LTV part 218-21136-7 up approximately 4 inches along the cowling (Fig. 6).

Although the seals added at the corners of the cowlings reduced intensities at those points to acceptable levels, a high transmission area was present along the cowlings on

both left and right sides at the curved section immediately above the patched hole as shown in Fig. 6. There was an apparent mismatch between radius of the cowling and radius of the fwd movable segment of the TRC. Measurements of this area indicated a transmission level of 36 footcandles on the right radius during the third set of readings taken. It was not as severe earlier and seems to be reduced significantly when the TRC is closed pneumatically.

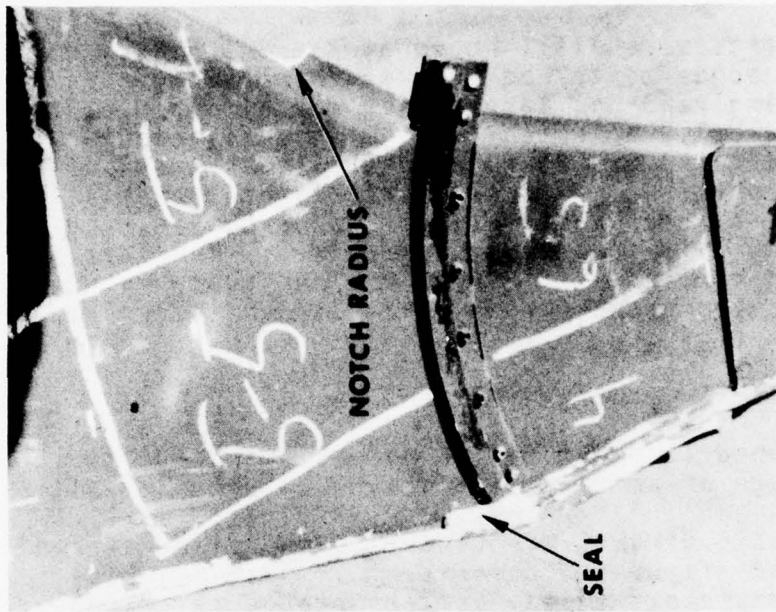
FIGURE 7. MOVABLE SEGMENT REWORK TYPICAL

SEGMENT AFTER REWORK

SEGMENT BEFORE REWORK

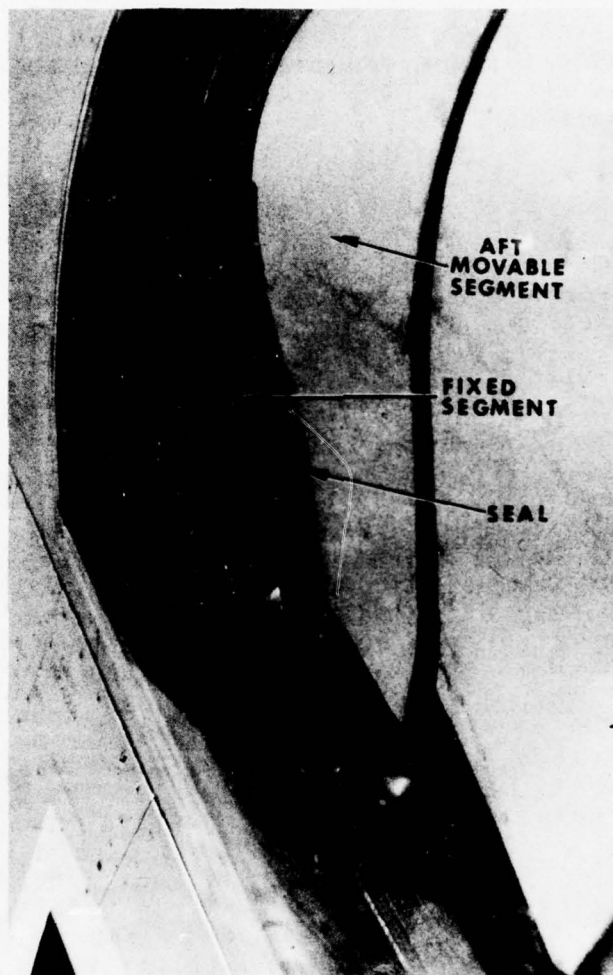
FIGURE 8. FIXED-SEGMENT SEAL INSTALLATION RIGHT SIDE

Because of considerable binding from the seals installed on the fixed segment, the TRC was initially closed manually to prevent damage to the closure mechanism. It was noted that the right seal (Fig. 8) was pushing against the closure to such an extent that an excessive leak measuring 180 footcandles appeared along the interface between the aft movable segment and the fixed segment at positions R-6-5, R-5-6, and R-4-8. Conversely, the seal on the left side worked properly, and reduced all light transmission to a level of 0.7 footcandle which is within specification limits. The second set of measurements repeated after removal of these seals (Table 2) revealed that the reduction in light-transmission levels was directly attributable to presence of the seal material. Further, after seal removal, a direct light leak approximately 0.25 inch in diameter and measuring 260 footcandles was noted on the right side near the hinge.

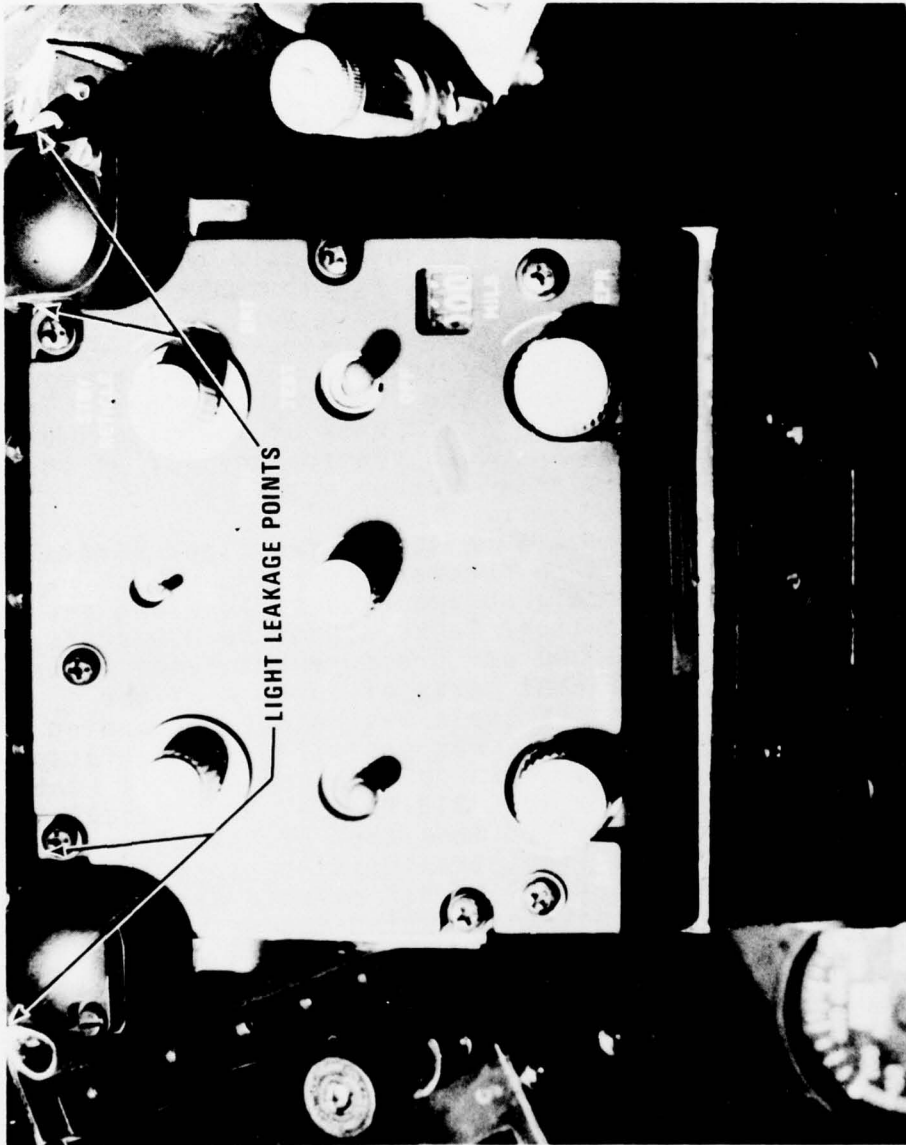
FIGURE 9. DIRECT LIGHT LEAKAGE POINTS ALONG HUD SEALS

Four direct light leaks, which allow light to shine directly in the pilot's eyes, were noted throughout this test series. Although they are not attributable to any fault of the closure, these direct leaks must be eliminated because of their position. Figure 9 defines these leak locations. A shield attached to the fwd movable segment could be positioned so that as the TRC closed, pinhole leaks would be eliminated from the direct view of the pilot; or a permanent seal could be added to the top portion of the HUD control panel to eliminate leakage paths

6. Direct light leaks, which are supposed to be eliminated by seal assemblies (LTV part Nos. 215-20078-187, -188, and -240), exist along the edges of the HUD. However, adjustments of these seals failed to remove four pinpoints of direct light which shine into the pilot's eyes. These leaks are not attributable to a fault of the TRC per se, but are definitely serious because of their position.

2. Eliminate direct light leaks to the pilot's eyes from positions along the HUD.
